# RECTIFICATION AND UPGRADING OF MECHANICAL AND ELECTRICAL WORKS AT PJA 229, BANDAR SRI DAMANSARA, SELANGOR DARUL EHSAN

## INTRODUCTION

PJA 229, Bandar Sri Damansara is an EAPS(Extended Aeration Pumping Station) plant located in the vicinity of Bandar Sri Damansara fronting the Sungai Buloh Expressway. It is a sizable plant with a PE of ?20,000. The client IWK (Indah Water Konsortium Sdn. Bhd.) had conducted a tender exercise which was eventually awarded to Ziphron Sdn. Bhd.

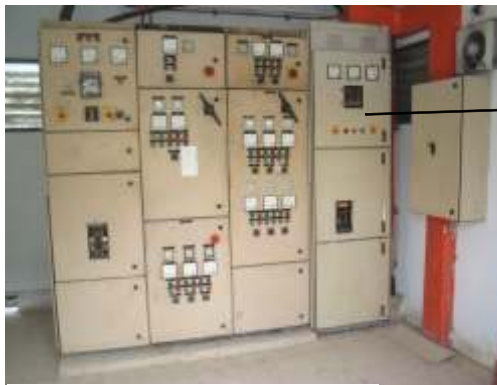
Fig. 1 Existing MCC panel

The incoming power supply is 300A and utilized an ACB (Air Circuit Breaker). The panel on the right (shown with arrow) is the incoming panel for PJA 242 and is not included in the scope of works.

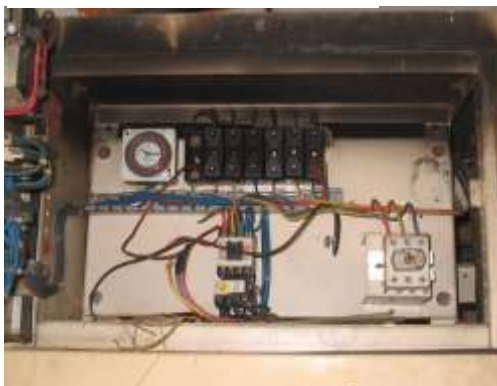
Fig. 2 Damaged MCC panel

The panel condition has deteriorated and there are signs of burning as can be seen in the photo on the right.

The new MCC panel was completed after ? 2 months and the major difference was the individual compartments that included all the existing equipments less the foam pumps which, in discussions with the client, were determined not to be severely detrimental to the effluent compliancy of the plant itself.

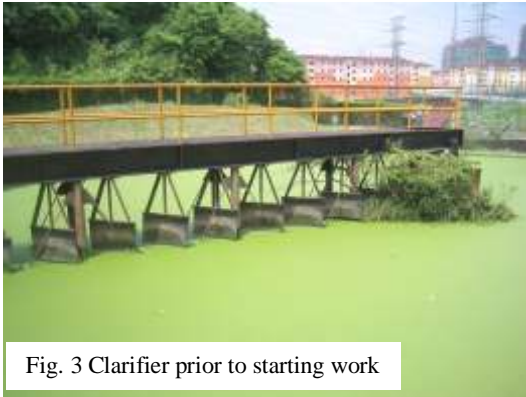
The major problem in the mechanical scope of works was the condition of the clarifier. This is clearly shown in the photographs below.

Fig. 3 Clarifier prior to starting work

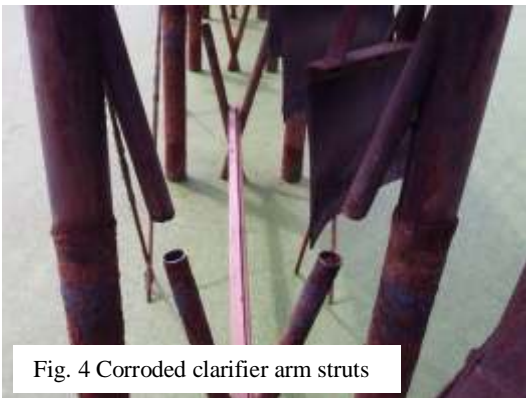
Fig. 4 Corroded clarifier arm struts

Clarifier had been inactive for quite a considerable time and due to that, there had been severe corrosion in the strut bars supporting the scrapper. The corrosion is evident at the water-line.

The struts too were repaired by removing the corroded struts and rejoining it with mild steel pipes of the same thickness and welded on site. Ref. Fig. 9

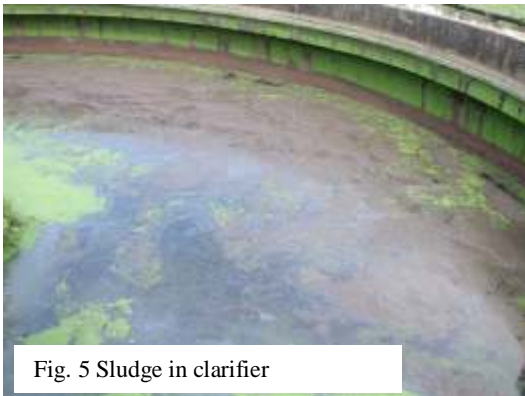
Fig. 5 Sludge in clarifier

Another effect of the clarifier being inactive was the accumulation of sludge in the clarifier, the actual depth of sludge was about 3 meters. Although desludging was not in the scope of works, it would be possible to proceed without it. So the decision, after discussions with the client, was to pump the sludge into the drying tank located on the side of the clarifier tank.

To complete the work on the clarifier all the sludge had to be pumped out, this took the better part of 1 1/2 week which was continuously hampered by the pumps being blocked by rubbish (as the pumps were not activated, rubbish had already bypassed the screen. The final clarifier after desludging can be seen in Fig 8 below.

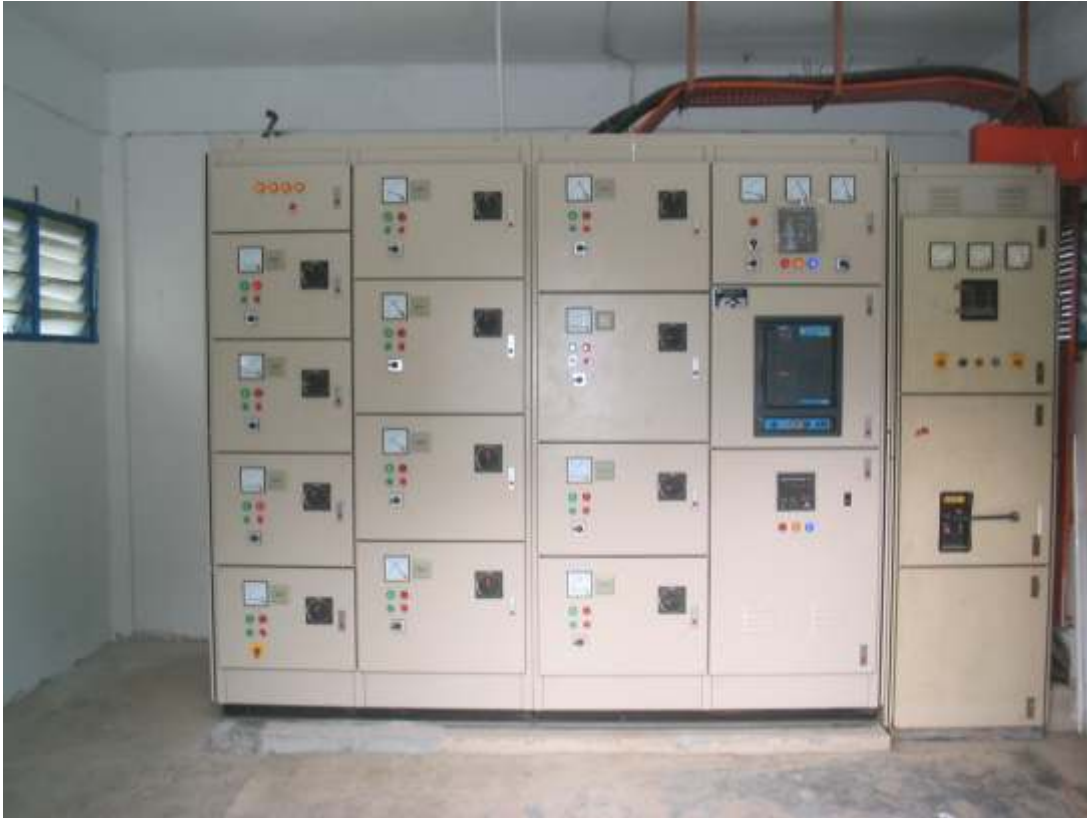
**Fig. 6 New Motor Control Centre**

Due to the increased size, mainly the individual compartments, the toilet in the control panel room had to be demolished. The clearance of the control panel from the ground was also increased due to probability of flooding in the room, the height was ascertained by the water line mark which was visible prior to the painting.

The MCC was constructed in two parts to facilitate its positioning in the control room

The incoming was again as before isolated with the use of an ACB of a withdrawable type (Larsen & Toubro) which was flush with the panel which on the other hand improved its aesthetic value. A capacitor bank was installed to maintain the ideal power factor which through observance of the Power Factor Meter was seen to be between 0.9 and unity. An EFR/OC (Earth Fault and Over Current Protection Relay) was installed and calibrated by Ziphron.

Individual compartment were installed with individual MCCBs (Moulded Case Circuit Breakers) complete with lockable handles (TERASAKI). Contactors utilized were manufactured by FUJI.

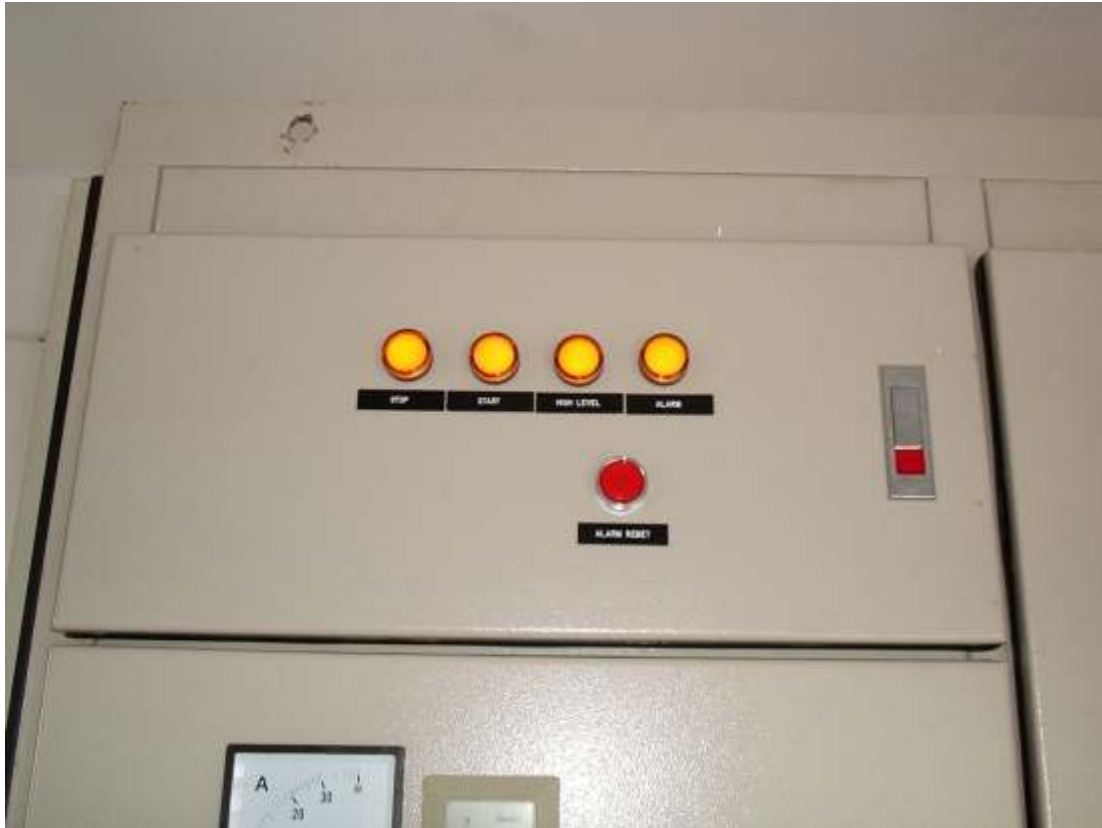
A separate compartment was utilized for easy evaluation of the level control switches of which there were four that corresponded to the individual float (SARLIN) levels. Ref to fig 7

**Fig 7 Level Control Switches Compartment**

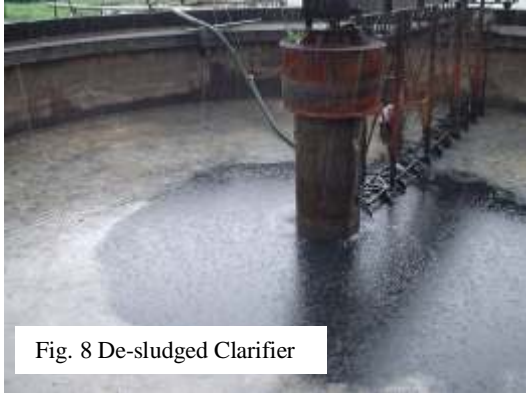
Fig. 8 De-sludged Clarifier

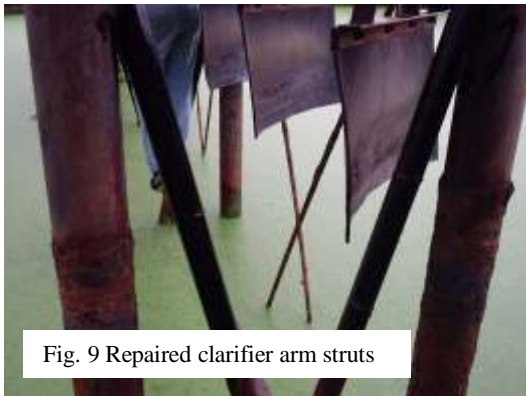
Fig. 9 Repaired clarifier arm struts

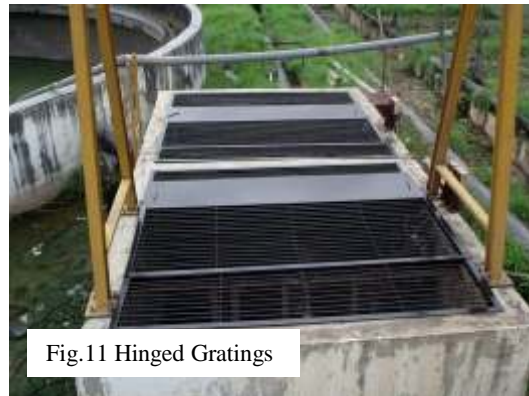
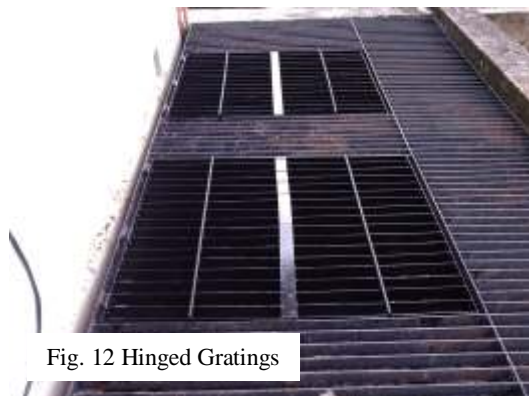
Fig.11 Hinged Gratings

Fig. 12 Hinged Gratings

The other mechanical works are somewhat minor and includes replacement hinged gratings for the raw sewage pump sump and for the sludge pump sump and foam pump sump which were initially covered with concrete slabs which were unwieldy especially for the operation and maintenance of the plant itself. The guide rails for the raw sewage pumps too had been removed from its place and the level control switches were either missing or required replacement, the control panel room too required a fresh new coat of paint as well as a sheet metal door. This items were included in the scope of works.

The hinged gratings were installed subsequently as shown in Figs. 11 and 12

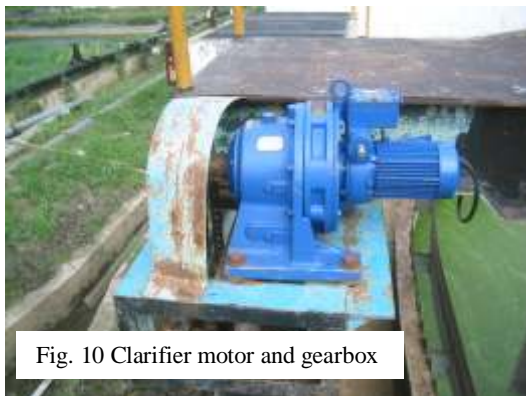
In our pre-mobilisation investigation we had discovered that the motor for the clarifier scrapper was still in good condition, however the seals for the SUMITOMO CYCLODRIVE® gearbox was damaged and had leaked the gear-oil. (Further investigation by Sumitomo had discovered the bearings and \_\_\_\_\_ to be damaged). The deterioration in the gearbox was more to disuse than to wear and tear due to the running of the gearbox itself. As the gearbox was fitted with a torque limiter, there was sufficient confidence that the gearbox would not be severely damaged if at all.

Fig. 10 Clarifier motor and gearbox

The clarifier and motor after replacement of damaged parts were returned and later installed as seen in Fig. 10.

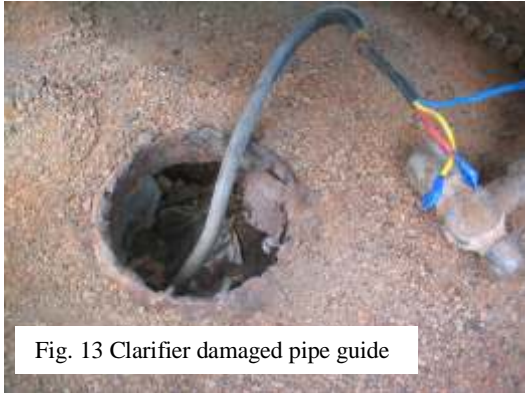
The major problem encountered happened during the testing of the clarifier scrapper. The wheel jumped track and dislodged. Under inspection, it was discovered that a pipe that acted as a guide for the clarifier had corroded and the stress caused the pipe to break up as shown in Fig. 13.

Fig. 13 Clarifier damaged pipe guide

As a solution, a pipe was used of a higher thickness to offset the long term effects of corrosion.

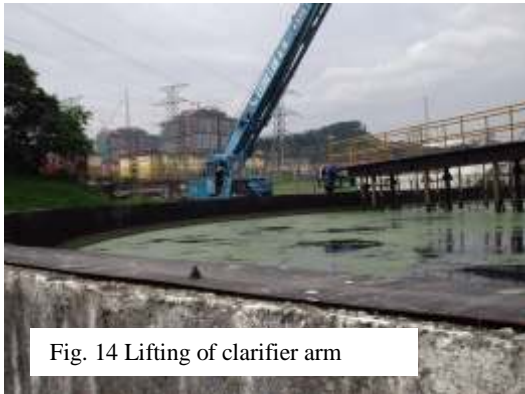
Fig. 14 Lifting of clarifier arm

To proceed with the work a 20-tonne crane was employed Fig. 14 in lifting up the entire scrapper arm and the new pipe was installed in place. Fig. 15.

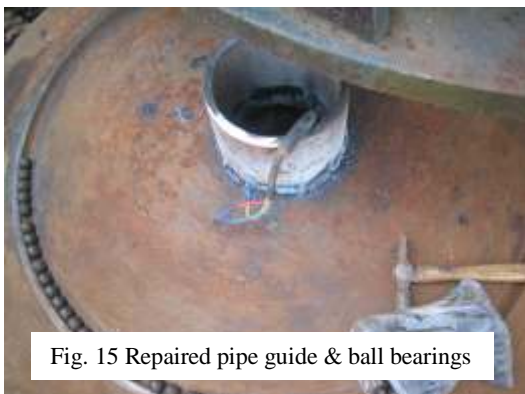
Fig. 15 Repaired pipe guide & ball bearings

The surrounding area around the pipe was also cleared from debris and metal shavings, the ball bearings was greased and reinstalled.
